**Harmony Timber Floors - Spotted Gum 180mm Wire Brushed BKB - Wet Sliptest
MO191022-11**

Slip Resistance Classification of New Pedestrian Surfaces - AS4586:2013 Appendix A

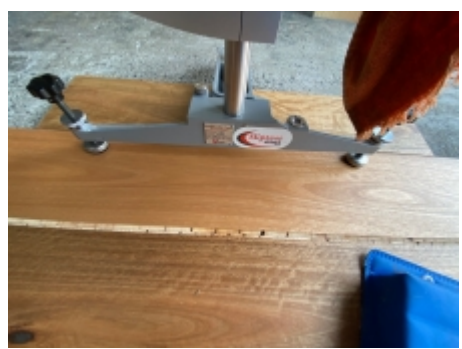
Sample No.	Swing 1	Swing 2	Swing 3	Swing 4	Swing 5	Mean BPN of last 3 swings :	SCV :	Surface Picture
Sample 1	55	55	54	53	53	53	N/A	
Sample 2	45	45	45	45	45	45	N/A	
Sample 3	43	42	42	42	42	42	N/A	
Sample 4	44	44	43	43	43	43	N/A	
Sample 5	42	41	41	40	40	40	N/A

Reported SRV For Test Area : 45

CLASSIFICATION using Slider 96 (4S Slider) P4 = 45 - 54
